METALS HANDBOOK

VOL. 9
FRACTOGRAPHY AND ATLAS OF FRACTOGRAPHY

8th EDITION

Fractography and Atlas of Fractographs

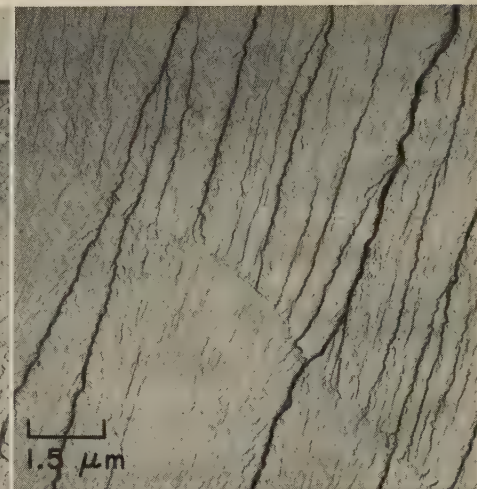
TEM fractograph (p-c replica) 6500×
4583 TEM replica of a second area of the facet at the arrow in 4581, showing features resulting from transgranular cleavage and cleavage steps that cross a tilt boundary extending from lower right to upper left. The approximate direction of crack propagation was from lower left to upper right.

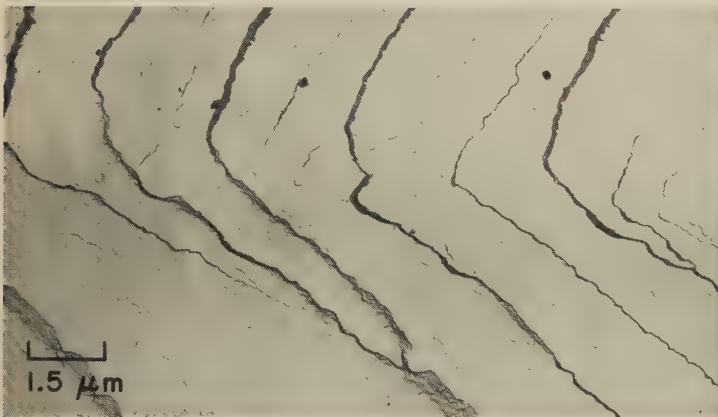
TEM fractograph (p-c replica) 6500×
4584 TEM replica of a third area of the facet at the arrow in the fracture surface shown in 4581. Although no sharp boundary is visible, it appears certain that the cleavage steps, which entered from the top in this view, cross a tilt boundary at mid-height, where they change direction.

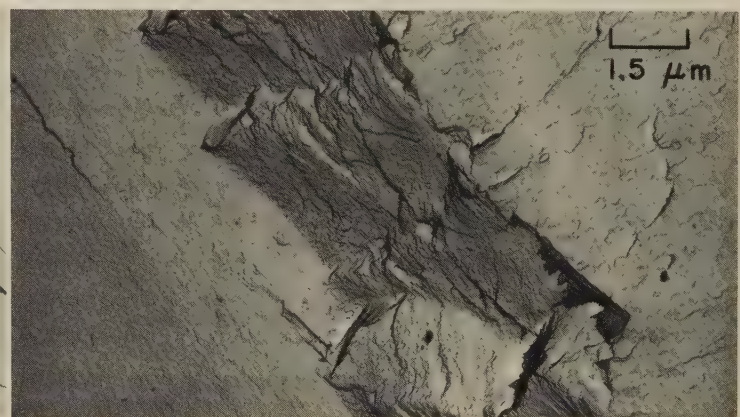
TEM fractograph (p-c replica) 6500×
4585 TEM replica of a fourth area of the facet at the arrow in 4581, showing evidence that here fracture occurred in two different directions and on two different levels. The appearance of the fracture region that connects these two levels (diagonal dark band) has been markedly affected by local microstructure.

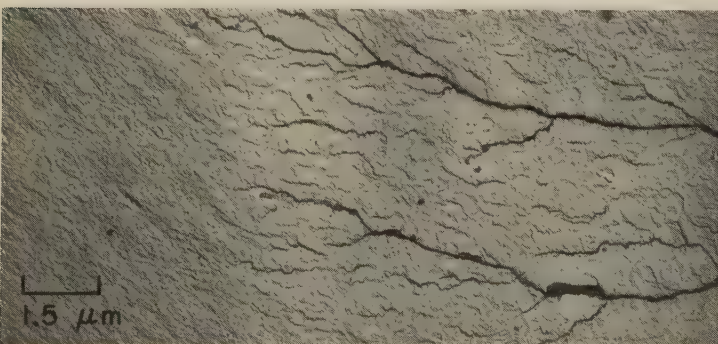
TEM fractograph (p-c replica) 6500×
4586 TEM replica of a fifth area of the facet at the arrow in 4581. The fracture entered this area from the left and, at a tilt boundary, began the formation of cleavage steps, creating a river pattern "flowing" toward the right.

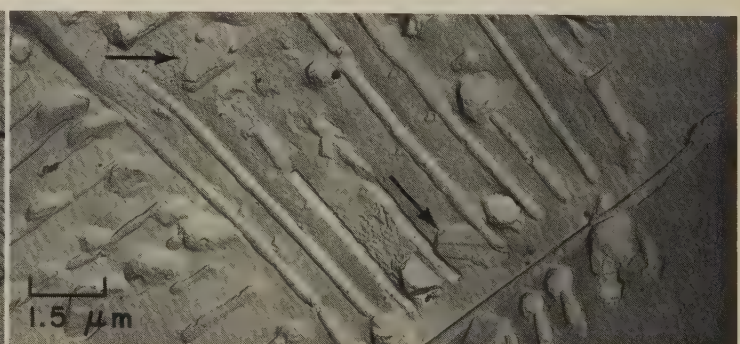
TEM fractograph (p-c replica) 6500×
4587 TEM replica of a sixth area of the facet at the arrow in 4581. This area contains features that could be cleaved second-phase particles or imprints of pulled-out particles. Also visible is a geometric array of rodlike second-phase particles.

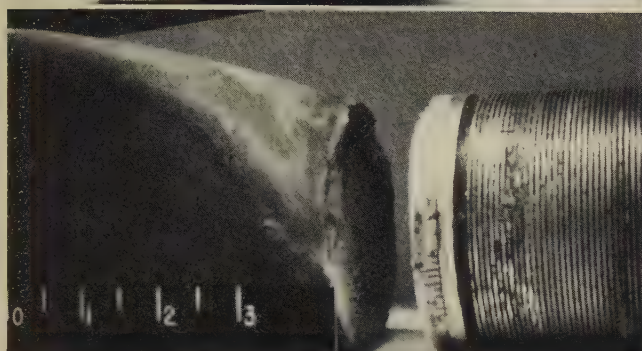
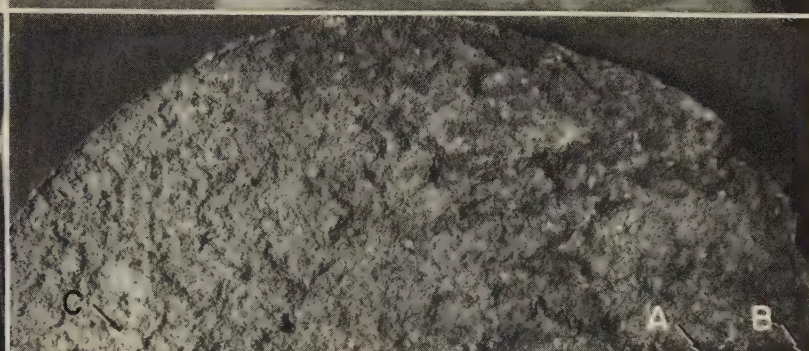
Photographs About 0.1× (4588); 0.4× (4589)

4588 Two photographs of a cooling-tower fan blade of aluminum alloy 319 (as sand cast) that fractured after about 20,000 hr of service in four years. Rated speed was 320 rpm. Fracture was attributed to stress-corrosion cracking that began in areas of shrinkage porosity produced during casting. See 4590 to 4597.

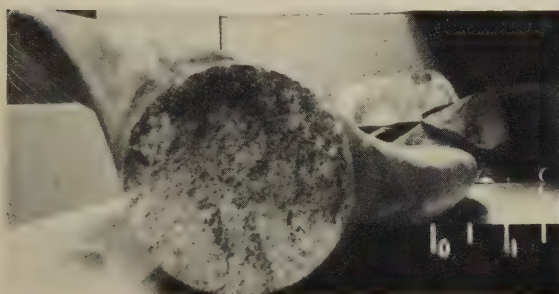
Photograph About 0.4×

4592 A view of the fracture surface of the aluminum alloy 319 fan blade shown in photographs 4588 and 4589. The darker area at top here corresponds to the region at right in 4591. Nominal operating stress (surface tension plus bending) was estimated as 17 MPa (2.5 ksi).

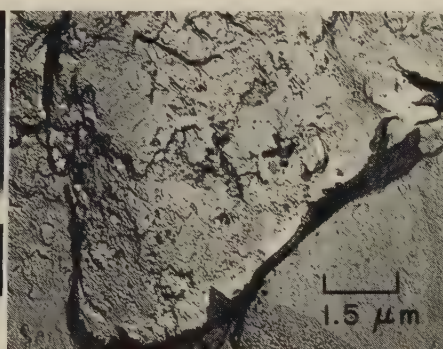
TEM fractograph (p-c replica) 6500×

4593 TEM replica of an area at A in the fracture surface in 4591, showing a casting defect (cold lap). No evidence of fatigue marks, or of impact by foreign objects, is visible.

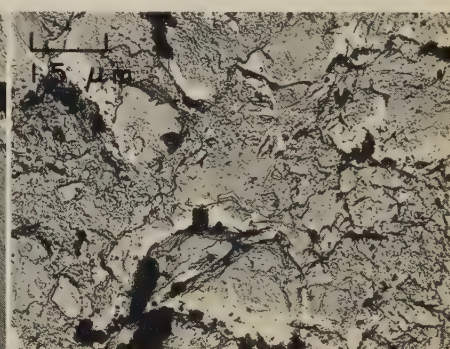
TEM fractograph (p-c replica) 6500×

4594 An area at B in 4591. Here, the surface appears intergranular in part, but also shows transgranular cleavage facets. Note unexplained fine "ripples", both here and in 4593.

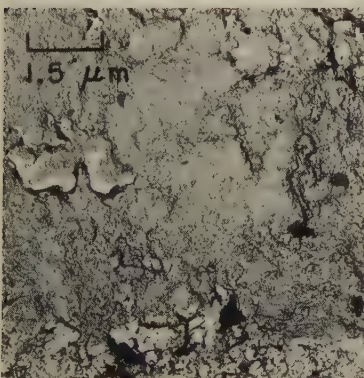
TEM fractograph (p-c replica) 6500×

4595 TEM replica taken from an area at C in 4591. This area is in the lighter region at left in 4591, which was found to be generally flat and to contain both intergranular and transgranular facets.

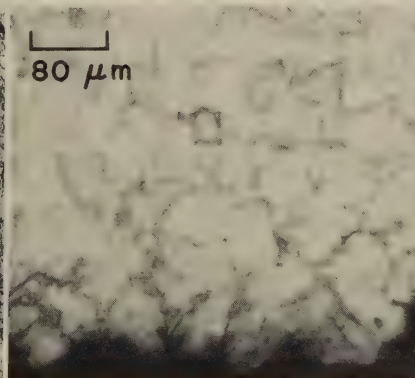
Micrograph (Keller's reagent) 125×

4596 A polished and etched section of the fan blade shown in 4588 and 4589, taken perpendicular to the fracture surface at C in 4591. The aluminum matrix contains a nearly continuous dendritic network of hard precipitate particles.

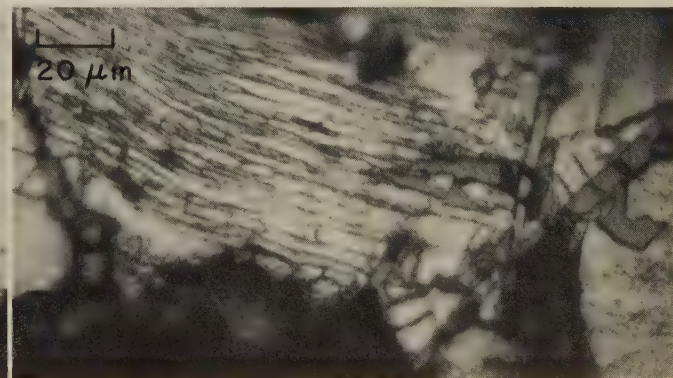
Micrograph (Keller's reagent) 500×

4597 Polished and etched section of the fan blade shown in 4588 and 4589, taken perpendicular to the fracture surface in the region at right in 4590, near a large casting defect. The parallel lines are not fatigue striations but rather are a series of parallel straight cracks, which suggest severe local embrittlement of the matrix; these small cracks are believed to have promoted stress-corrosion cracking.

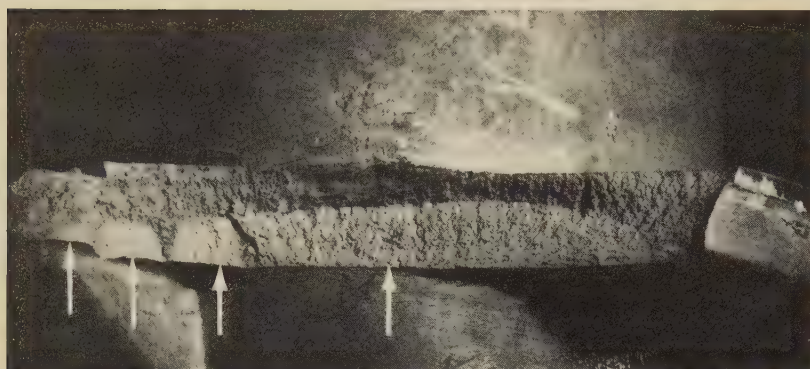
Light fractograph

4598 A fatigue-test fracture in a steering-gear upper cover, die cast of aluminum alloy 380. The cover was tested in one-way-bending fatigue with a load of 17,120 newtons (3850 lb) and broke at 13,300 cycles. The fatigue cracks are the lighter areas on the lower side of the fracture surface; four crack origins are visible (arrows). See also 4599 to 4603.

4601 A TEM replica obtained from the fracture surface shown in 4598. Within the aluminum matrix there are the well-defined fatigue striations (arrow 1) of a conventional fatigue fracture. The intermetallic compounds, however, fractured by cleavage (arrow 2).

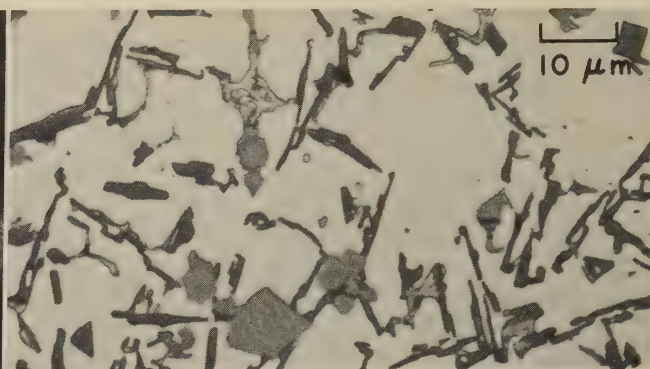
Light micrograph (etchant: 0.5% HF in water)

1000×

4599 A polished and etched section through a specimen of the die-cast aluminum alloy 380 used for the cover in 4598. The white background is the aluminum matrix. Scattered through it are second-phase particles. See also micrograph 4600.

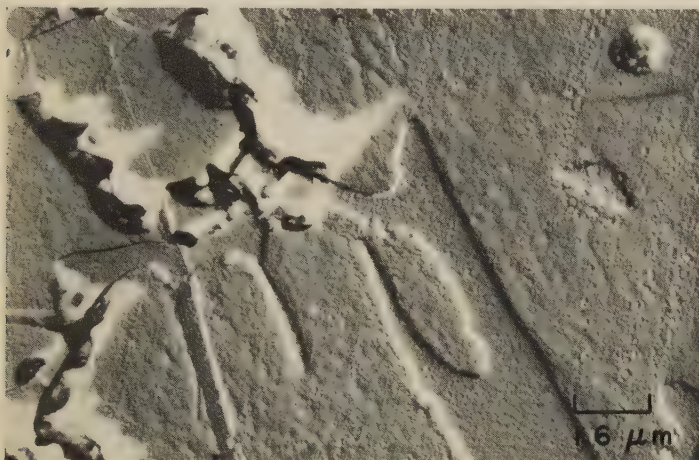
TEM micrograph (etchant: 0.5% HF in water); p-c replica

6100×

4600 TEM replica of the polished and etched surface of the specimen in 4599. This shows some of the angular second-phase particles in relief, thus permitting comparison of particle size with features in TEM fractographs 4601-4603, which follow.

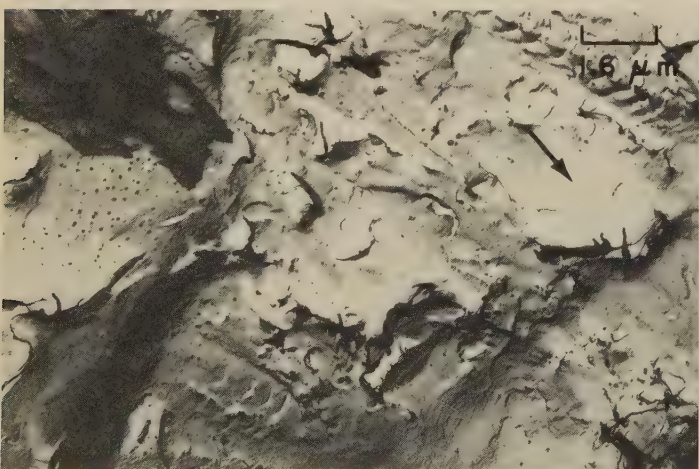
TEM fractograph (p-c replica)

6100×

4602 A TEM replica of a one-way-bending fatigue fracture in a steering-gear upper cover similar to that in 4598 except tested at a load of 21,740 newtons (4890 lb) and broken at 100 cycles. Typical "tire tracks" are visible at upper right, and slightly below and to left of center. There appear to be stretched areas (as at arrow). Intermetallic compounds fractured by cleavage.

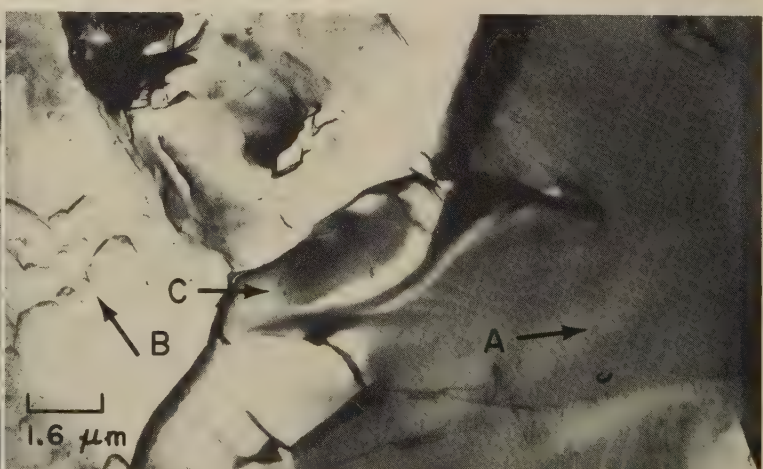
TEM fractograph (p-c replica)

6100×

4603 A TEM replica taken from the fracture surface of a third steering-gear cover, die cast of aluminum alloy 380, which broke on the first cycle of loading at 40,650 newtons (9140 lb). Fracture of the matrix was predominantly intergranular (arrow A), although isolated areas show elongated dimples (arrow B). Second-phase particles fractured by cleavage (arrow C).

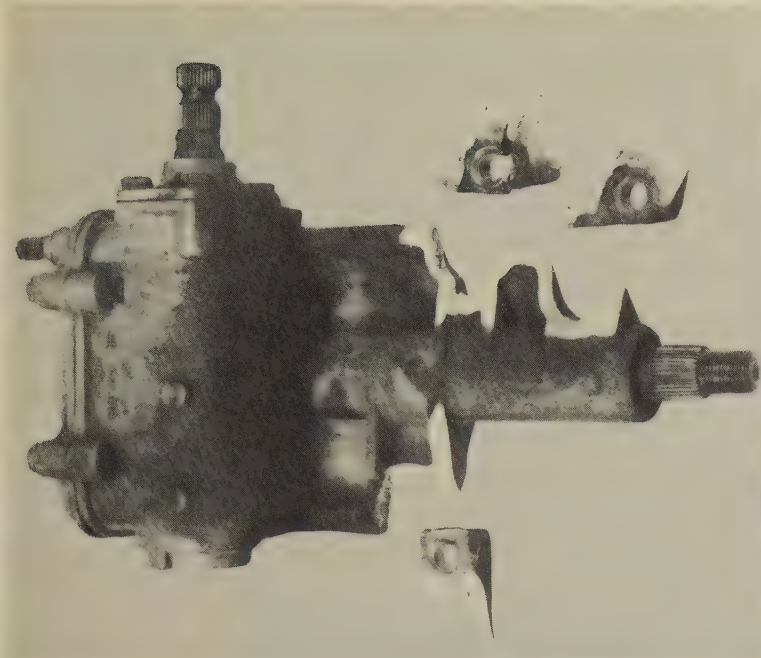
Photograph

About $\frac{1}{4} \times$

4604 A steering-gear housing, die cast of aluminum alloy 380, which fractured at the mounting-bolt bosses under a test impact. The steering gear was mounted on a movable sled and rammed into a barricade, tearing the housing from the frame. The three fractured bosses are shown near the locations from which they broke. See also 4605 to 4607.

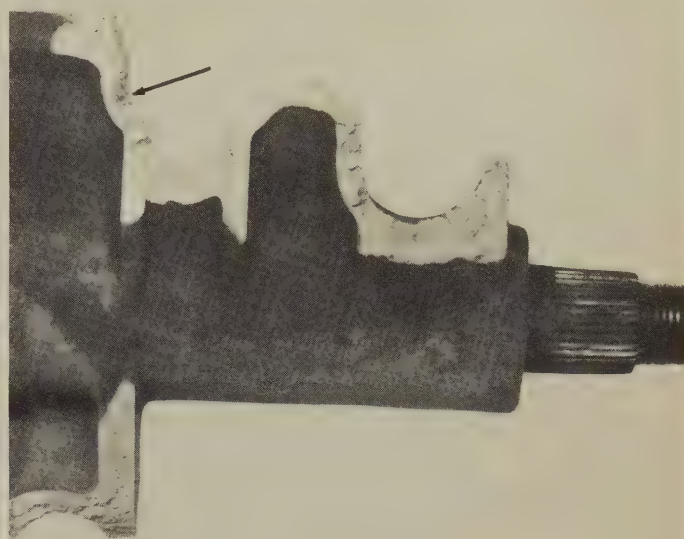
Light fractograph

$\frac{1}{2} \times$

4605 A half-size view of the fracture surfaces on the steering-gear housing in 4604. This view does not include the mounting-bolt bosses. The arrow marks the mating surface to that of the boss shown in fractograph 4606, below.

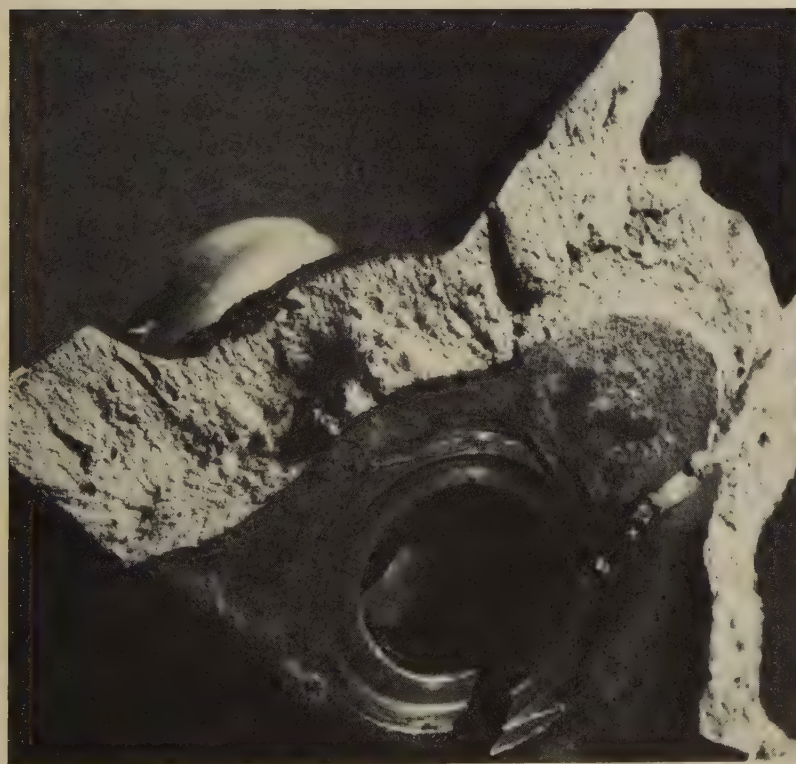
Light fractograph

$2 \times$

4606 Fracture surfaces of the mounting-bolt boss that was separated from area at arrow in 4605 by the impact. Note the chevron marks faintly visible along the lower edge of the fracture surface at left; these point diagonally upward to the right toward the fracture origin. See 4607 (right) for a TEM replica of the area containing the chevron marks.

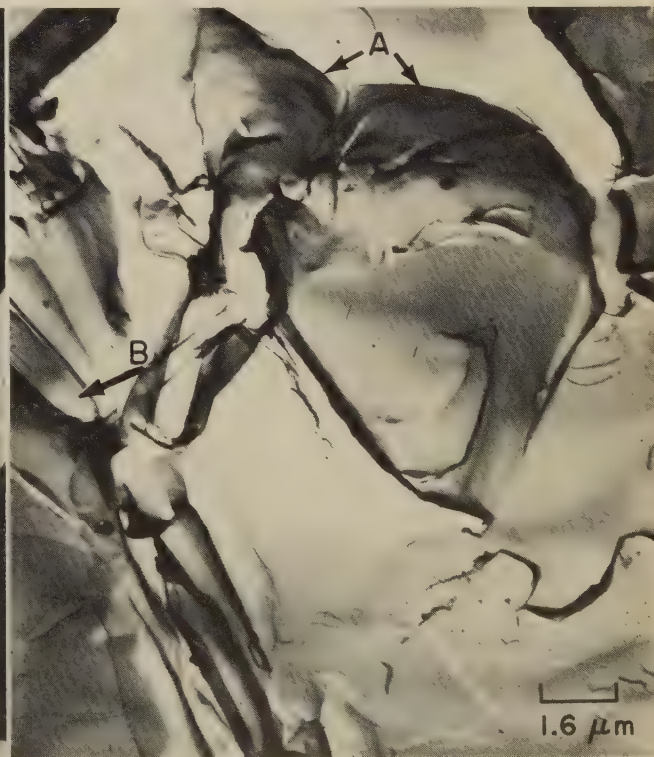
TEM fractograph (p-c replica)

$6100 \times$

4607 A TEM replica of the area containing the chevron marks in 4606. Some features here appear to be artifacts caused by difficulty in stripping the plastic replica. The fracture surface is predominantly intergranular (as at A). Second-phase particles fractured by cleavage (B).

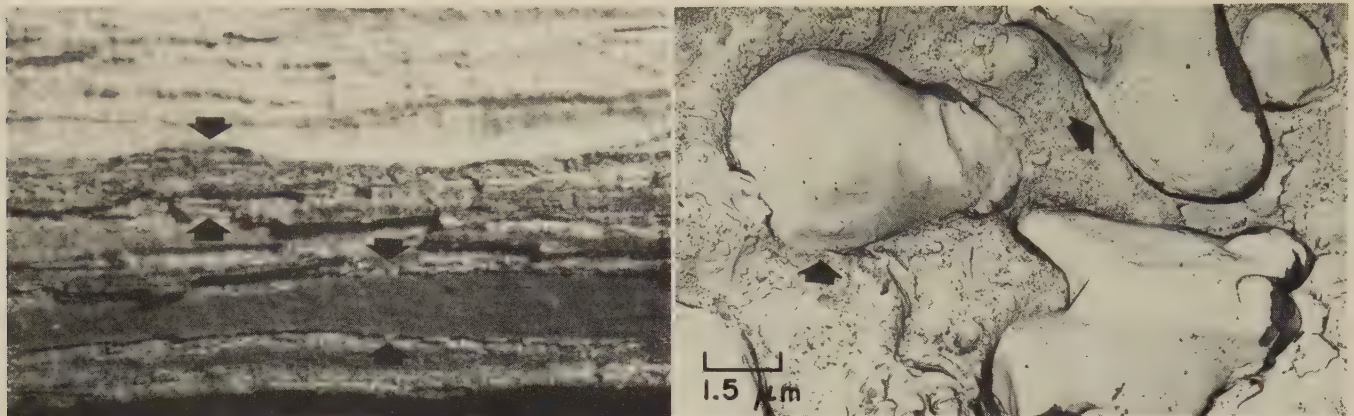
4608, 4609

Light fractograph

20×

Light and TEM views of two areas of the surface of a fracture in a forging of aluminum alloy 2018, showing segregated inclusions. Fractograph 4608 (left) shows bands (between pairs of arrows) containing slag (lower band), and other residue (upper band), entrapped during casting of the forging ingot. Fractograph 4609 (right) is a TEM replica of an area in one of the bands in 4608, showing globular inclusions (as at arrows). Some of these inclusions exhibit conchoidal solidification marks. The areas between the inclusions contain oxide residues and evidence of poor bonding.

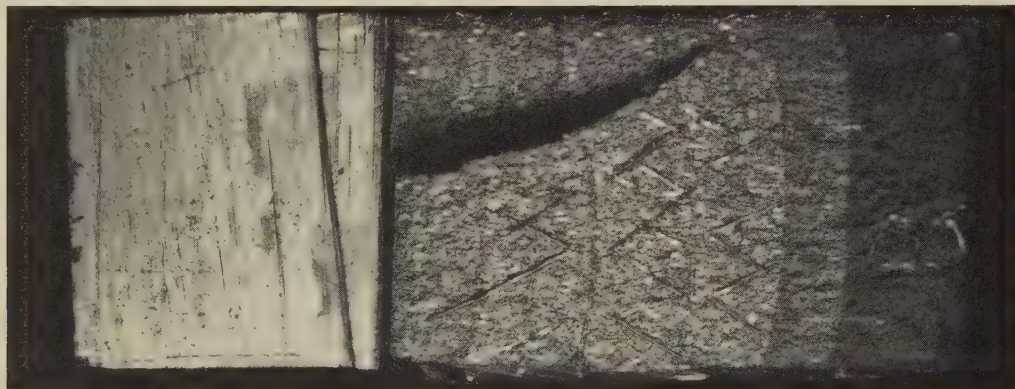
Light fractograph

8×

Surface of a fatigue fracture in a notched specimen of aluminum alloy 2024-T3 that was cracked in stages using different amplitudes. The third zone from right (six zones are visible), for instance, was produced at a low amplitude whereas the second zone from right was formed at a high amplitude. Crack growth (left to right) was produced by cantilever bending, generally at 2.5 cycles per second, with minimum load always zero. See also 4611 to 4615.

4611 TEM replica of a low-amplitude area of the fracture surface in 4610. Stress-intensity range (ΔK) was 11 MPa·m^{1/2} (10 ksi·in.^{1/2}). The major portion of each striation is flat or, at most, slightly contoured. The striations are delineated by fissures or crevices.

4612, 4613 TEM replicas of mating areas of the fatigue fracture of which one entire surface is shown in 4610. Fatigue striations generated by five high-amplitude cycles (center) are bounded by striations generated by low-amplitude cycles. Stress-intensity range (ΔK) was 21 MPa·m^{1/2} (19 ksi·in.^{1/2}). The five widely spaced striations are well preserved in fractograph 4612 (left), but 4613 (right) shows only randomly spaced fissures that resulted from extraneous slip, which occurred after the crack front had passed by.

4614 TEM replica of an area in 4610 (facing page) that shows fatigue striations produced at high amplitudes. The center region of each striation is quite smooth, almost as if created by stretching; the regions between these center regions are rumpled and convex (when observed in correct stereoscopic perspective). Also visible are occasional tear dimples, each of which extends across a striation.

4615 TEM replica of another area in 4610 showing fatigue striations produced at high amplitudes. Here the striations are much less sharply defined than in 4614. Numerous small tear dimples are present. Comparison with the mating surface (not shown) revealed that reverse plastic flow during the closing half of the fatigue cycle modified the two faces independently.

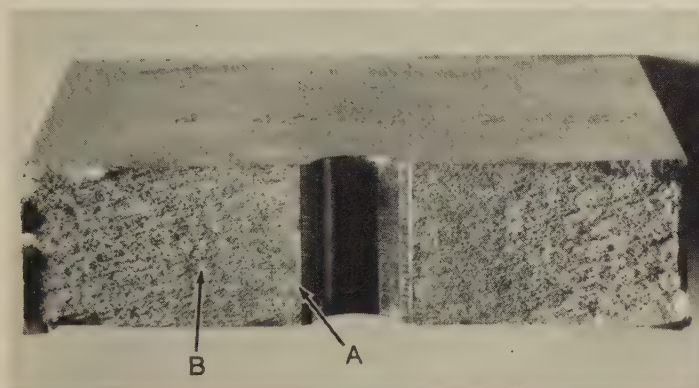
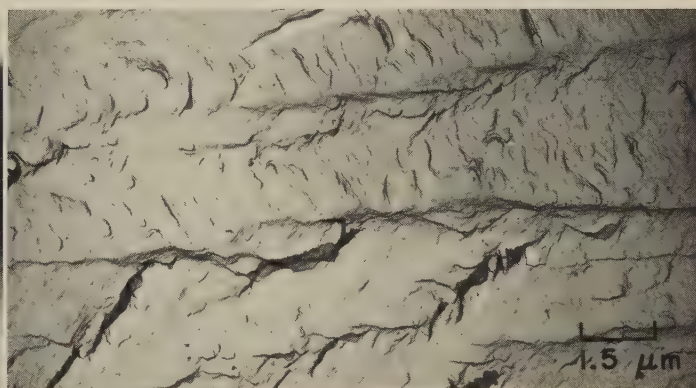
4616, 4617

Light fractograph

Actual size

Fractograph 4616 (left) shows the surface of a high-cycle fatigue fracture in a notched specimen of aluminum alloy 2024-T851 plate with a tensile strength of 490.2 MPa (71.1 ksi). The fracture exposed a hole drilled through the center of the specimen and notches immediately to left and right of the hole. The specimen was loaded in tension transverse to the grain direction, at room temperature, to a stress cycled from 22.7 to 64.8 MPa (3.3 to 9.4 ksi), and broke after 229,700 cycles. The fracture surface is flat and shiny with a shear lip at each end. Fractograph 4617 (right) is a TEM replica of the fracture surface at the notch (marked A) in 4616, showing fatigue patches containing vaguely defined striations. See 4618 and 4619 for TEM replicas of two areas at arrow B in 4616.

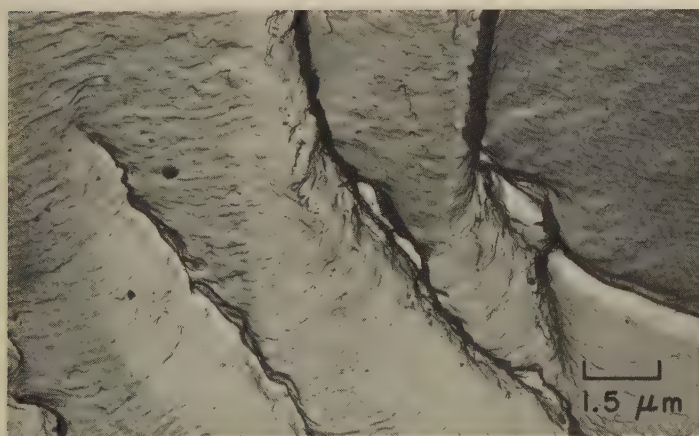
TEM fractograph (p-c replica)

6500×

4618 TEM replica of an area at arrow B in 4616, showing regular, well-defined fatigue striations in patches created by local crack fronts. These patches occasionally subdivide, as seen at top left, at a discontinuity such as an intermetallic particle.

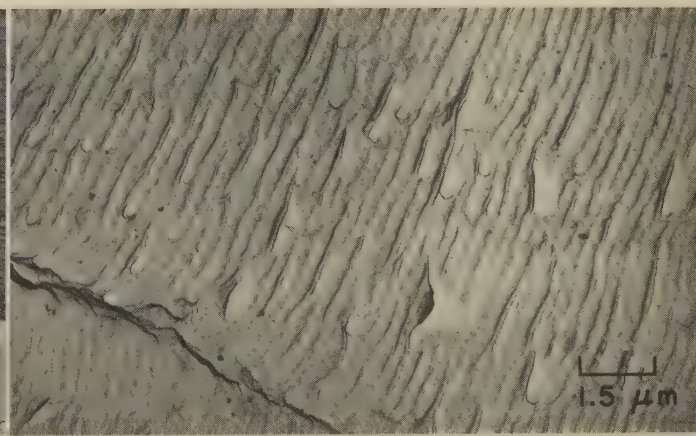
TEM fractograph (p-c replica)

6500×

4619 TEM replica of another area at arrow B in 4616. In this area, there are numerous fissures among the fatigue striations, and it is difficult to distinguish random fissures from crack-closure fissures delineating striations.

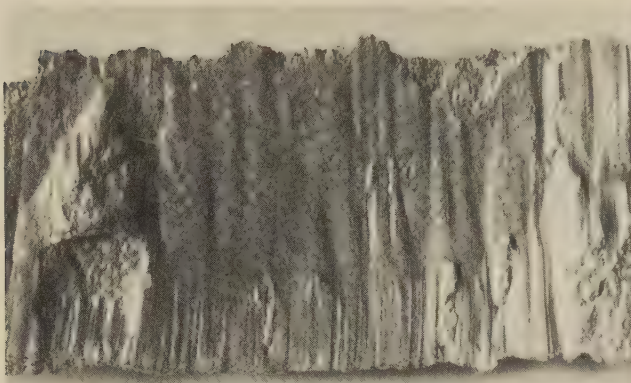
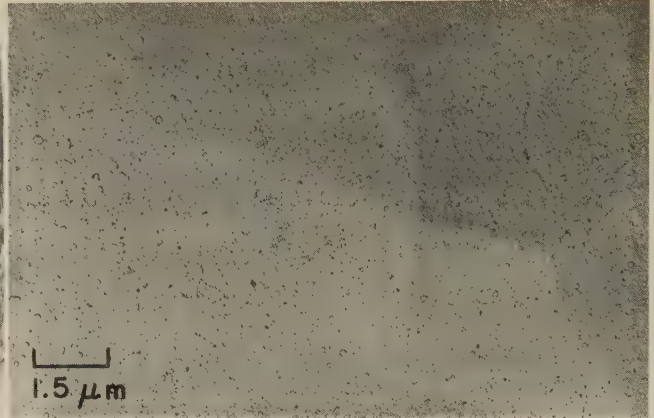
4620, 4621

Light fractograph

2× TEM fractograph (p-c replica)

6500×

Light and TEM views of the surface of a fracture in a forged part of aluminum alloy 7075-T6. The fracture was caused by internal shearing during the forging operation. Internal shearing, which usually is termed "flow-through", is a defect that frequently extends through the full thickness of the part. The characteristics of the flow induced during forging are visible in 4620 (left). Fractograph 4621 (right) is a TEM replica of an area of the fracture surface in 4620, showing a surface that is flat and virtually featureless, with vague indications of grain boundaries.

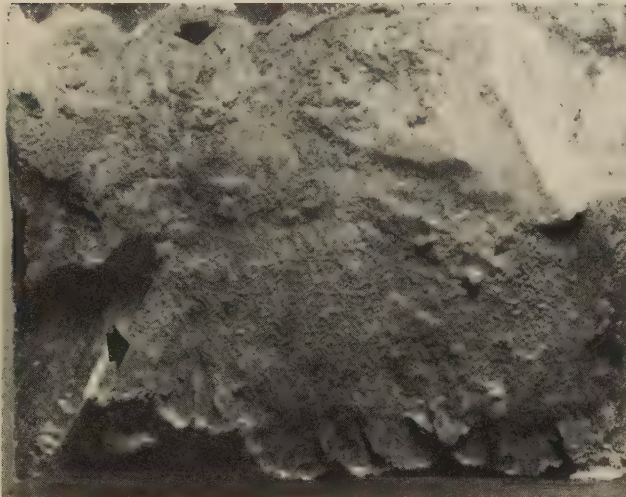
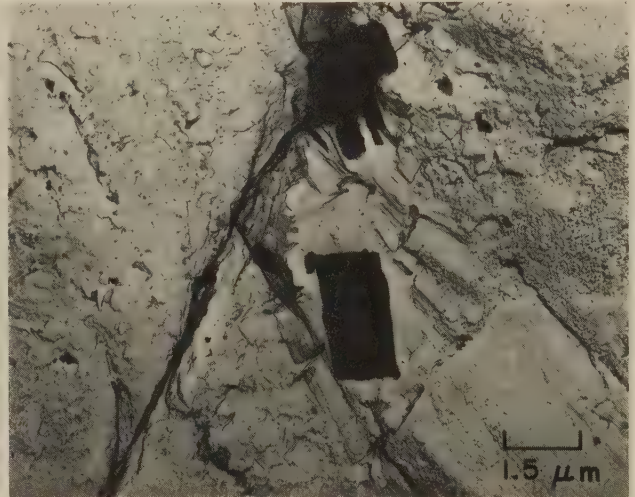
4622, 4623

Light fractograph

3× TEM fractograph (p-c replica)

6500×

Light and TEM views of the surface of a fracture in a forged part of aluminum alloy 7075-T6. The fracture originated at cold shuts that resulted from the closing of forging laps. The surface of one cold shut is shown bounded by the arrows in 4622 (left); this surface is fairly flat and bears a layer of oxide particles. Fractograph 4623 (right) is a TEM replica of an area of the cold-shut surface in 4622, showing oxide, and black regions that may be particles picked up from the fracture surface by the replica.

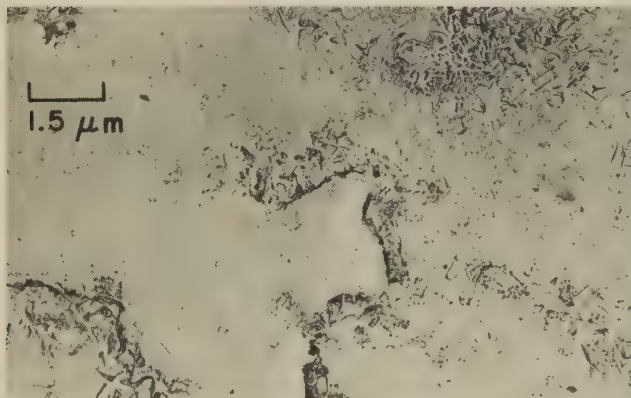
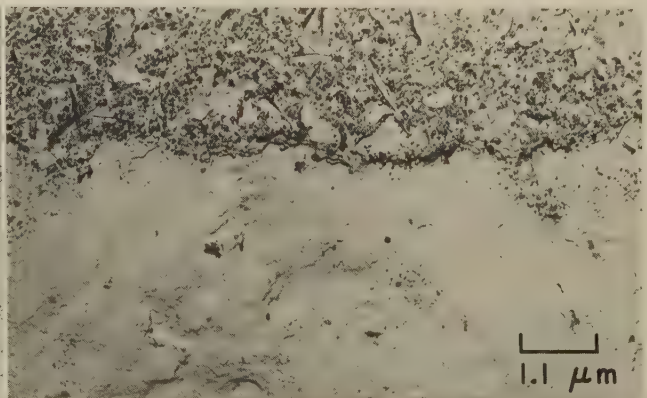
4624, 4625

TEM fractograph (p-c replica)

6500× TEM fractograph (p-c replica)

9300×

TEM replicas of two areas of the surface of a fracture in a forged aluminum alloy 7075-T6 support for a cargo-door cylinder. The fracture, which originated at a cold shut, formed at an attachment hole that extended above and below the cold shut. These TEM replicas reveal that the fracture surface is flat and encrusted with oxide particles.

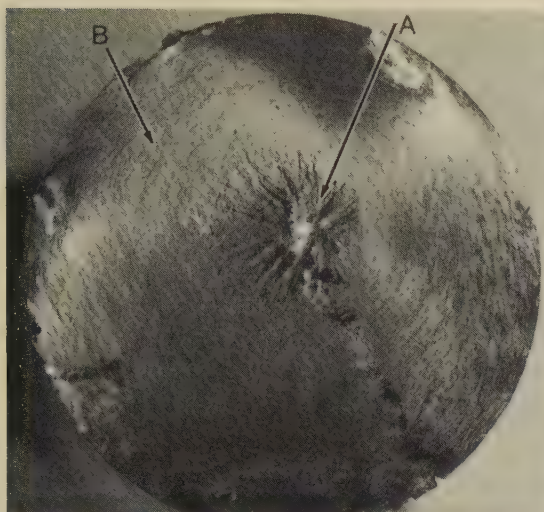
Light fractograph 5×

4626 A torsion-overload fracture in a forged billet of aluminum alloy 7075-T6, with a tensile strength of 572 MPa (83 ksi), that broke at room temperature. Flat, silky outer portion of fracture surface was rubbed in torsion. Note star-shaped pattern at center. See 4627 to 4629.

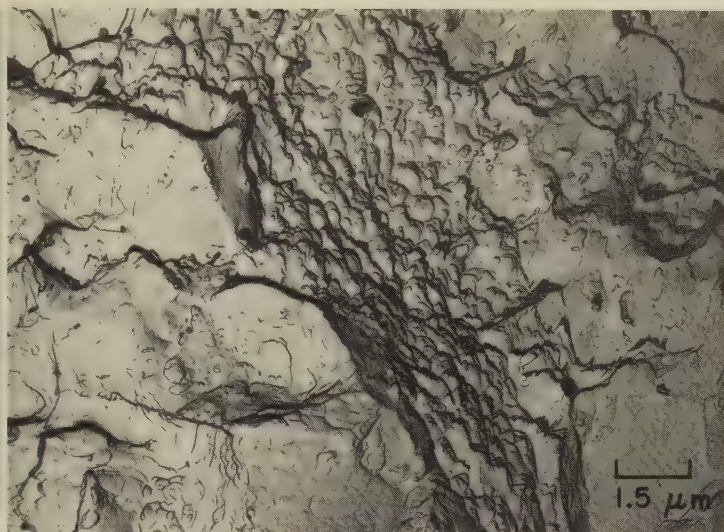
TEM fractograph (p-c replica) 6500×

4627 TEM replica of an area within the star-shaped pattern at arrow A in the center of the fracture surface shown in fractograph 4626. Broad regions containing dimpled separated-grain facets are present, as well as many adjacent flat facets that are suggestive of transgranular cleavage.

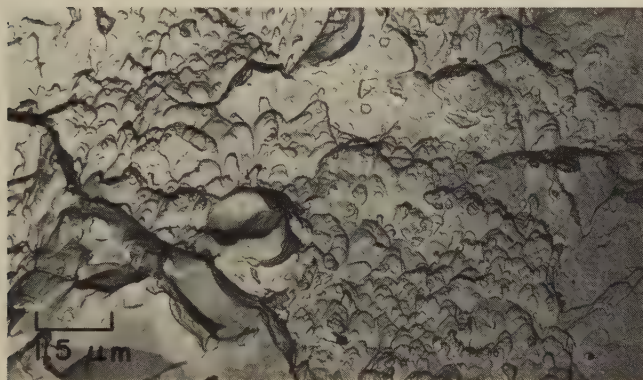
TEM fractograph (p-c replica) 6500×

4628 TEM replica of an area at arrow B in the outer portion of the fracture surface in 4626. Shear dimples such as those shown here were found throughout this portion of the fracture. The feature at bottom left apparently is a cleaved intermetallic particle.

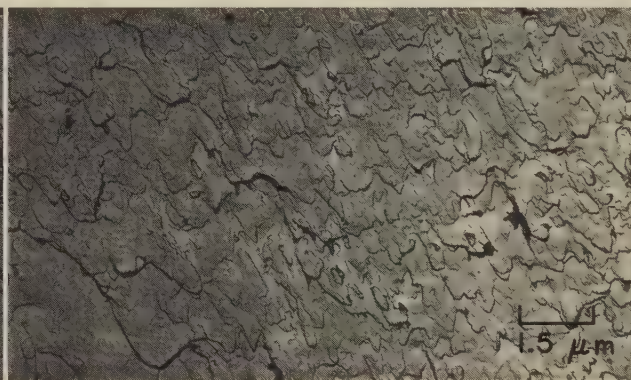
TEM fractograph (p-c replica) 6500×

4629 TEM replica of another area at arrow B in fractograph 4626. This area shows very flat shear dimples, which are interpreted as reflecting in part the rubbing that resulted from the torsional strain that occurred after the crack front had passed by.

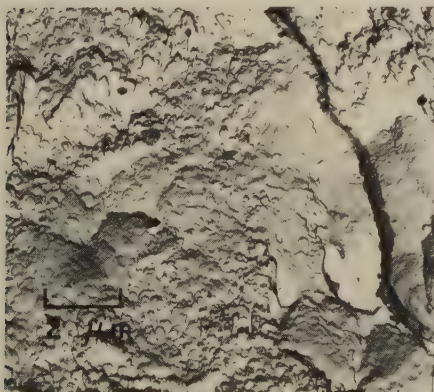
TEM fractograph (p-c replica) 5000×

4630 TEM replica of an area of the surface of an impact fracture in an aircraft component of aluminum alloy 7075-T6, showing very fine shear dimples. See also 4631 and 4632.

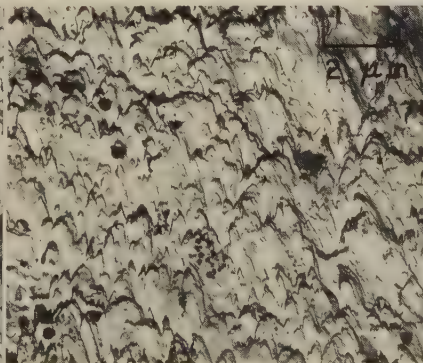
TEM fractograph (p-c replica) 5000×

4631 TEM replica of another area of the fracture surface shown in 4630. This area contains rather uniformly sized and uniformly oriented elongated dimples. Crack propagation was from top to bottom.

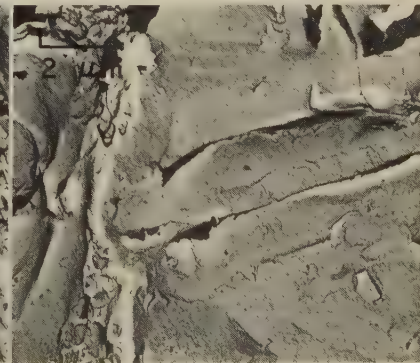
TEM fractograph (p-c replica) 5000×

4632 TEM replica of a third area of the fracture surface in 4630 and 4631, showing cleavage facets that may contain fine precipitates. These facets are interspersed with small regions of equiaxed dimples.

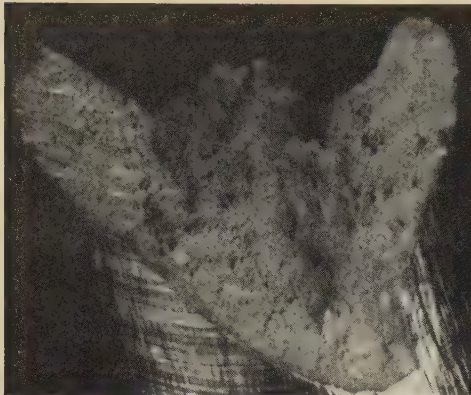
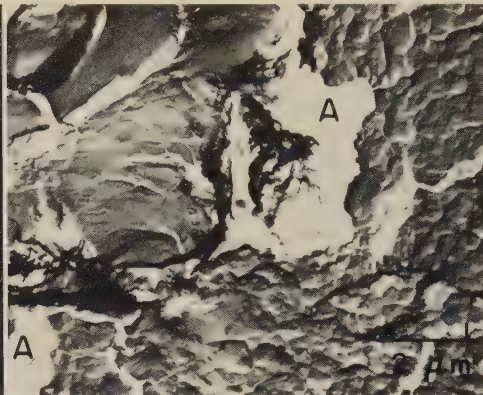
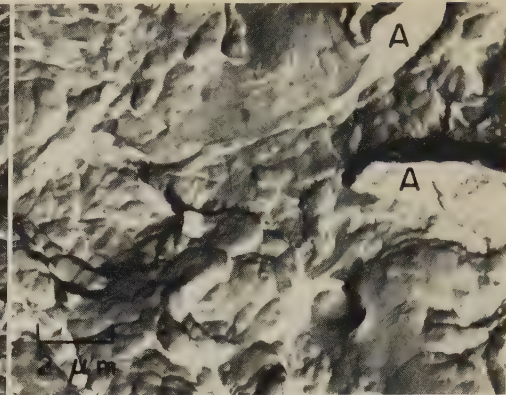
4633, 4634, 4635

Light fractograph

9x TEM fractograph (p-c replica)

5000x TEM fractograph (p-c replica)

5000x

Fractograph 4633 (left) shows the surface of a tension-overload fracture in an unnotched specimen of aluminum alloy 7075-T6 with a tensile strength of 520.6 MPa (75.5 ksi). Fractograph 4634 (center) is a TEM replica of an area in the central region of the fracture surface in 4633, showing uniform fine dimples and exposed surfaces of precipitate particles. Fractograph 4635 (right) is a TEM replica of another area in the central region of the fracture surface in 4633, showing dimples similar in size to those in 4634. In both 4634 and 4635, secondary cracks appear only as voids in the shadowing (white areas marked A). See fractograph 4636 for a TEM view of a third area of this fracture surface.

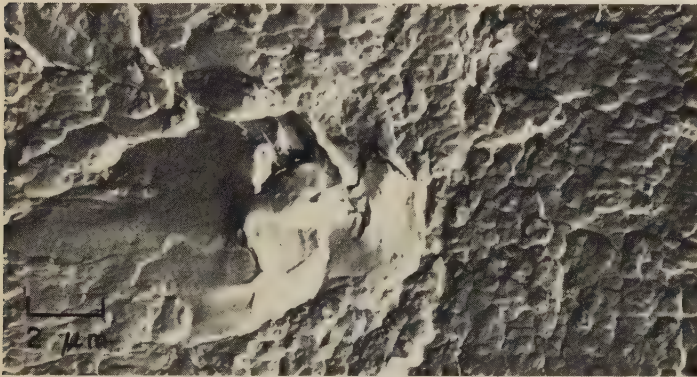
TEM fractograph (p-c replica)

5000x

4636 TEM replica of an area in the central region of the fracture surface in 4633 nearer the shear lip than the areas in 4634 and 4635, showing small dimples that appear to be slightly elongated. The large feature at center apparently is the surface of a precipitate particle exposed by the fracture.

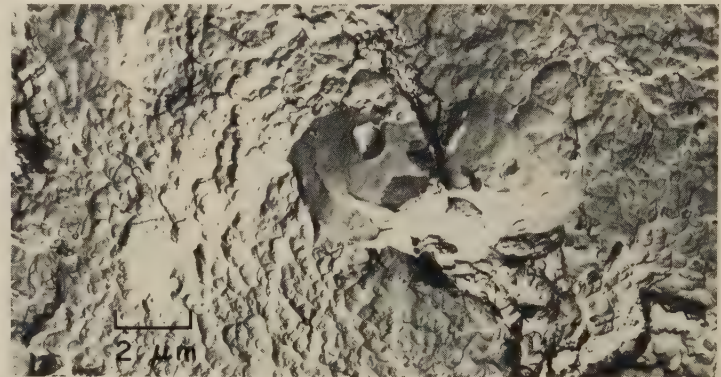
TEM fractograph (p-c replica)

5000x

4637 TEM replica of an area of the tension-overload fracture surface shown in 4638 (below, left). This area is composed mainly of fine dimples that in general appear to be equiaxed. A large dimple at center appears to contain a stretched-out hole that was left when a precipitate particle was pulled out.

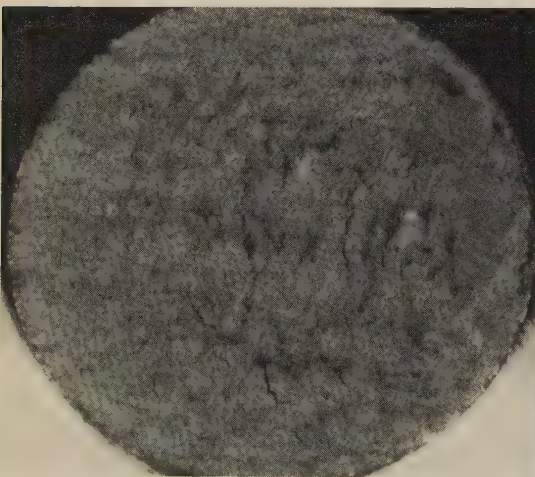
Light fractograph

4638 Tension-overload fracture in a notched specimen of aluminum alloy 7075-T6 with a notched tensile strength of 748.1 MPa (108.5 ksi). Unnotched tensile strength, same as in 4633. The surface is fibrous, with numerous secondary cracks. See also 4637, 4639 and 4640.

4639 TEM replica of an area of the fracture surface in 4638 showing cleavage facets of precipitate particles (lower right) and a region that appears to have been stretched (far lower right).

4640 TEM replica of an area of the fracture surface in 4638 showing small dimples, slightly asymmetrical in some regions. At right of center are two cleavage facets of precipitate particles.

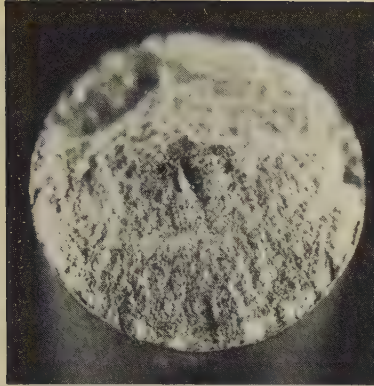
Light fractograph 6×
4641 Surface of a low-cycle fatigue fracture in a specimen of aluminum alloy 7075-T6 (same tensile strength as in 4633) tested in tension-tension ($R = 0.1$) with a maximum stress of 310 MPa (45 ksi). Specimen broke after 26,000 cycles. See fractographs 4642 to 4644.

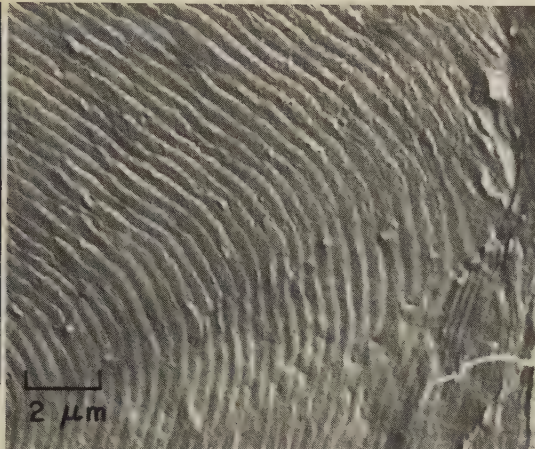
TEM fractograph (p-c replica) 5000×
4642 TEM replica of an area at the edge of the fracture surface in 4641, where fatigue striations apparently continue on the rounded edge of the specimen, which is severely deformed. Note the uniform change in direction of the striations.

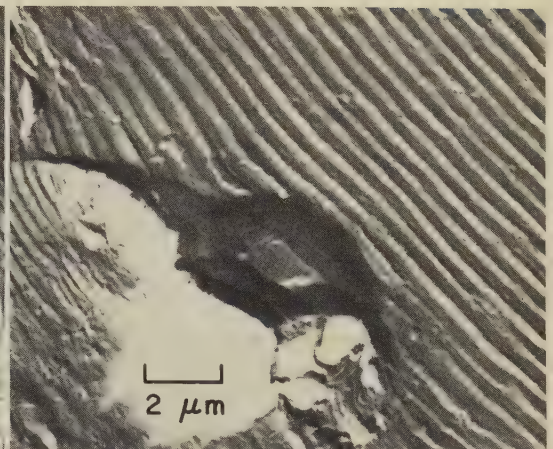
TEM fractograph (p-c replica) 5000×
4643 TEM replica of another area of the fracture surface in 4641, showing a pattern of very sharply defined fatigue striations interrupted by a precipitate particle just below center. Note the closer spacing of the striations just to left of the precipitate particle.

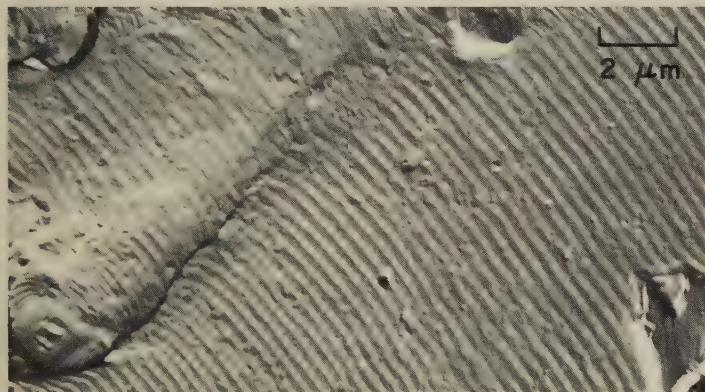
TEM fractograph (p-c replica) 5000×
4644 TEM replica of a third area of the fracture surface in 4641, showing portions of three fatigue-striation patches. Secondary cracks are visible between the patches.

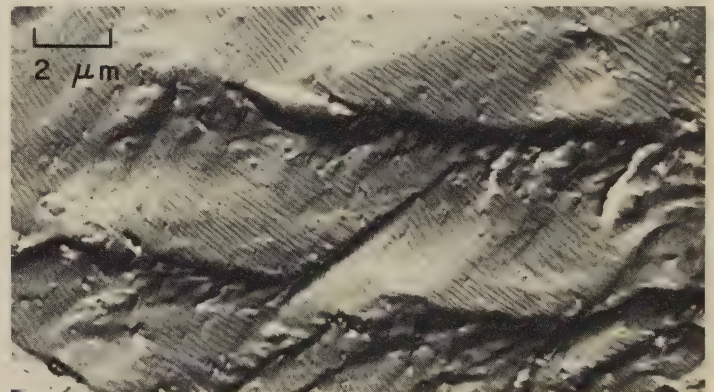
TEM fractograph (p-c replica) 5000×
4645 TEM replica of area near edge of fracture in 4646 (below, left), showing uniform fatigue striations interrupted by local steps where cracks at different levels joined.

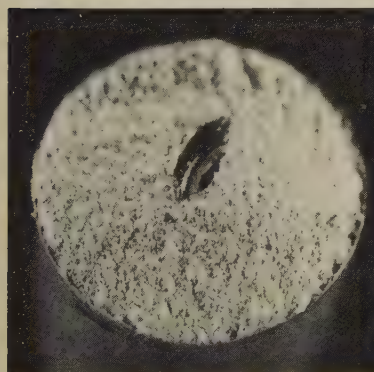
Light fractograph 6×
4646 Surface of a high-cycle fatigue fracture in a specimen of aluminum alloy 7075-T6 (same tensile strength as in 4633) tested in tension-tension ($R = 0.1$) with a maximum stress of 152 MPa (22 ksi). Specimen broke after 548,000 cycles. Gouge at center was made after fracture. See 4645, 4647 and 4648.

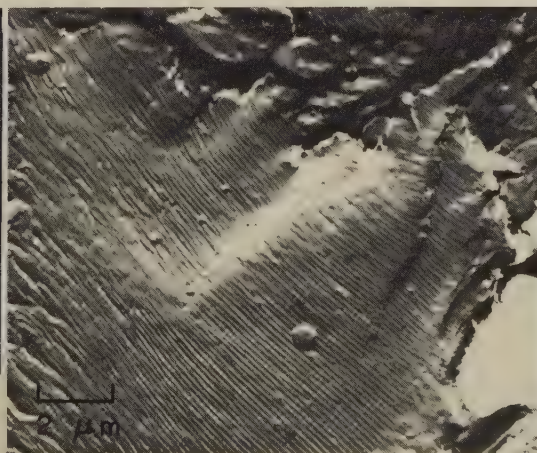
TEM fractograph (p-c replica) 5000×
4647 TEM replica of an area near the edge of the fracture surface in 4646 showing a system of steps (at top). What appears to be a void at lower right more probably is the result of a tear in the replica. The striation spacing here is very similar to that in 4645 and 4648.

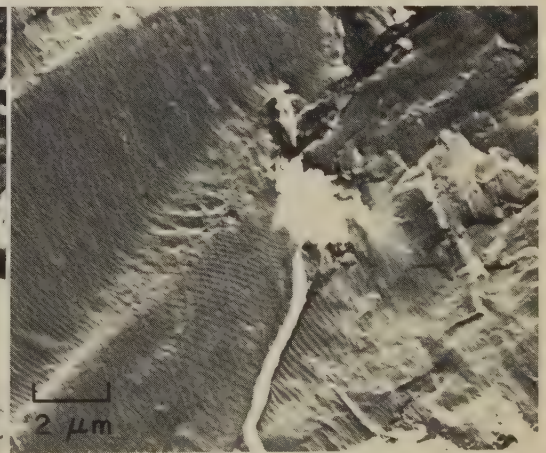
TEM fractograph (p-c replica) 5000×
4648 TEM replica of another area near the edge of the fracture surface in 4646, showing several fatigue patches separated by off-sets. The lack of clearly defined striations at upper right indicates that this region may be near a crack origin.

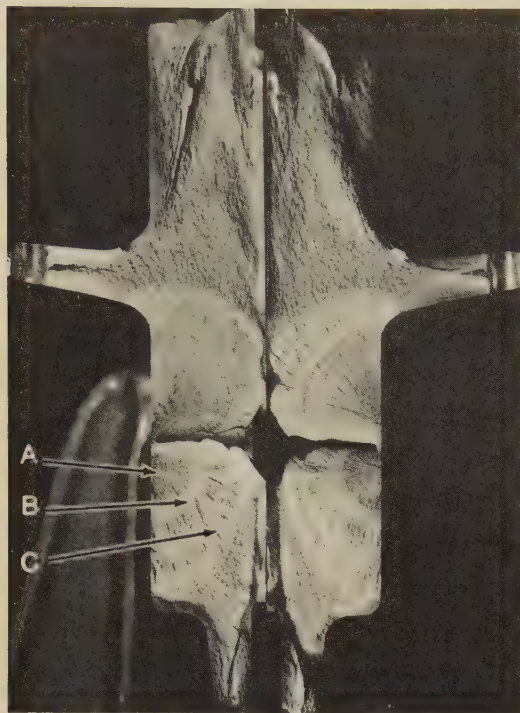
4649 Mating surfaces of a high-cycle fatigue fracture in an aluminum alloy 7075-T6 extrusion (tensile strength, 572 MPa or 83 ksi) subjected to a test program (repeated 16½ times) of 2000 cycles at each of 19 load patterns; fracture occurred after 629,035 cycles. Note "clamshell" marks on both sides of drilled hole. See 4650 to 4652 for TEM views of areas at arrows.

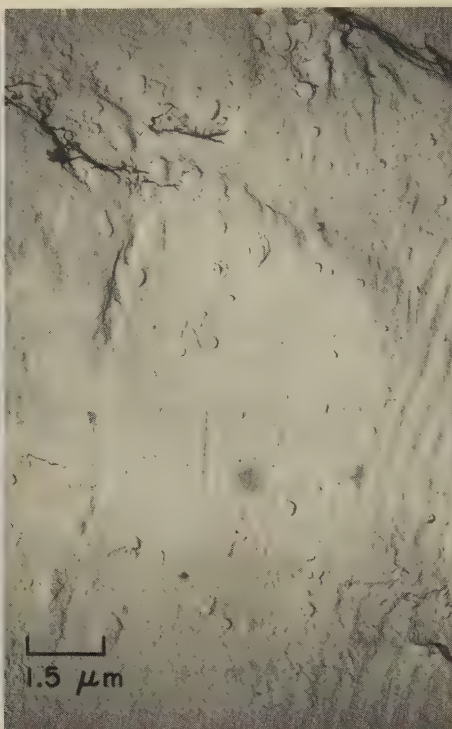
4650 TEM replica taken from an area at arrow A in the fatigue-fracture surface shown in fractograph 4649, near (but not at) the fatigue-crack nucleus. The difference in spacing of the fatigue striations from left to right reflects an increase in loading.

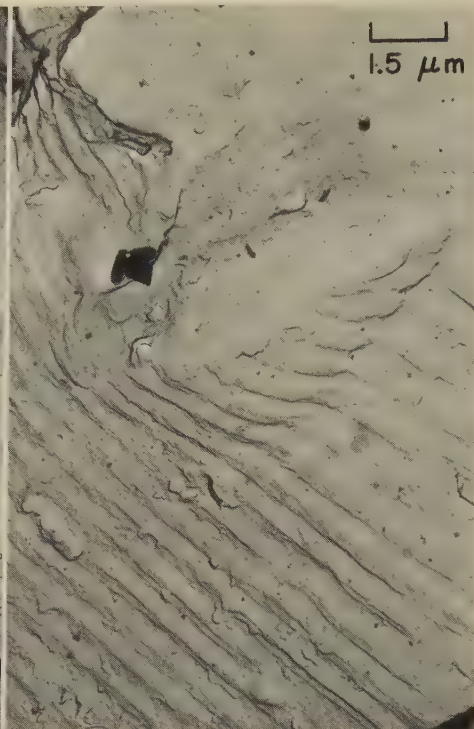
4651 TEM replica of an area at arrow B in 4649, farther from the crack origin than the area in 4650. Note the small change in fatigue-striation spacing at right center. The lines in the striations near bottom suggest slip subsequent to passage of the crack front.

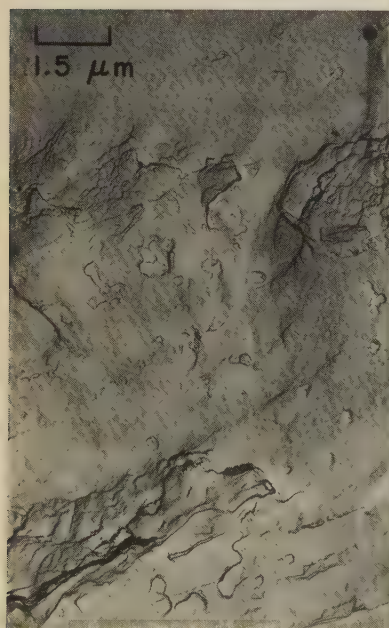
4652 TEM replica of an area at arrow C in 4649, still farther from the crack origin than the areas in 4650 and 4651, as is indicated by wide striation spacing and patches of dimples.

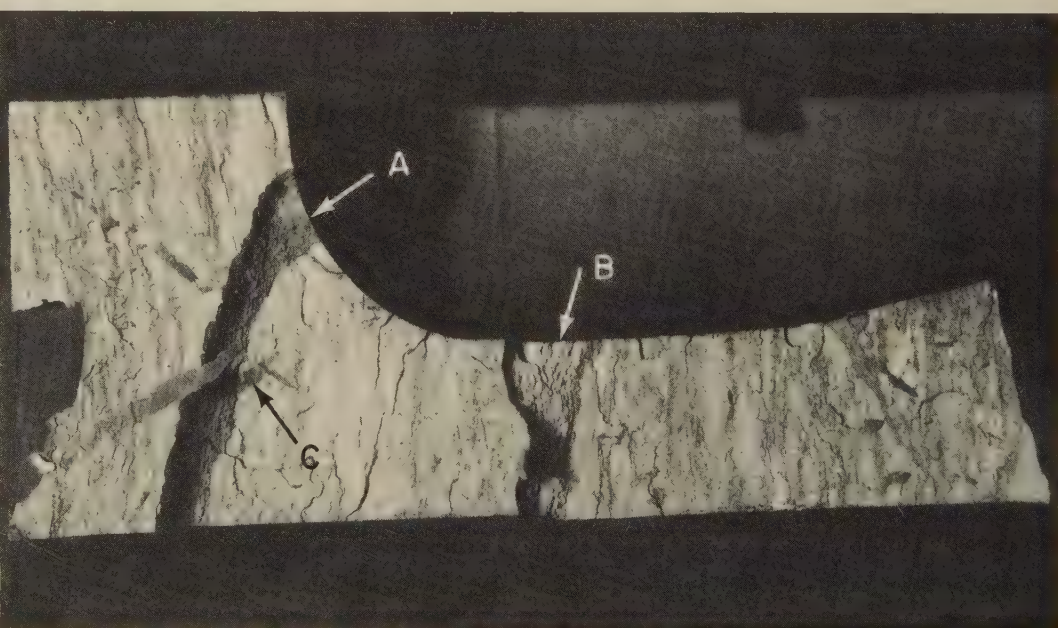
4653 Surface of a stress-corrosion fracture in a fitting of forged aluminum alloy 7075-T6. During sawing of the fitting to disclose the fracture surface it was found that high residual stresses existed at the centers of the thicker portions of the fitting. Corrosion resulted from exposure to a marine atmosphere. See also micrograph 4654 and fractographs 4655 and 4656 (opposite page), for sectional and TEM views of this fracture. Hardness was Rockwell B 89.5. Areas A and B are offsets in the fracture surface (note the shadow of the sliver at C).
